Manhole Inspection Summary

Manhole # S57EE_007MH

Insp Date: **3/19/08 11:02 AM**

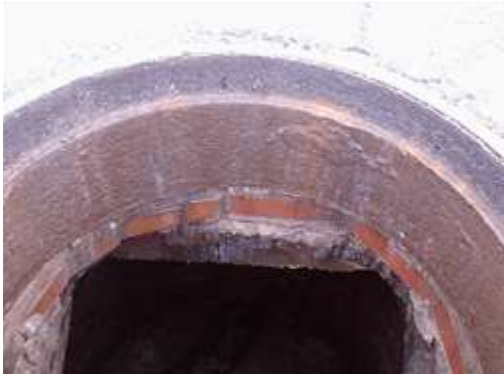
Defect 1

Condition: ☐ Sound ☐ Cracked ☐ Root Intrusion ☒ **Loose Brick** ☐ Deteriorated

Infiltration: ☐ None ☐ Joint ☐ Cracks ☒ **Mortar** ☐ Roots ☒ **Wall**

Adjustment Joint

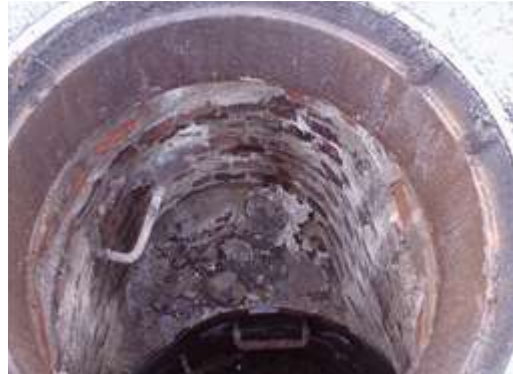
Defect 2

☒ **Leaks**

Frame Leaks

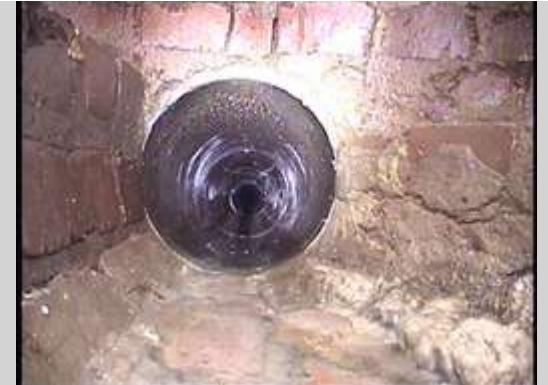
12 O'Clock Outflow

8 in. Circular Gravity Sewer
Pipe Out @ 12 O'Clock

Pipe Height: **8.4** (in.) Rod and Bar (Angled)
Pipe Material: **Clay** ☐ Pipe Lined
Invert Depth: **8.30** (ft.) Flow Characteristics: **Slow**
Deposits: ☒ None ☐ Mud ☐ Sludge ☐ Debris ☐ Grease
Silt Depth: (in.) Deposits Extent:
Infiltration: **None** Pipe Seal Cond: **Sound**

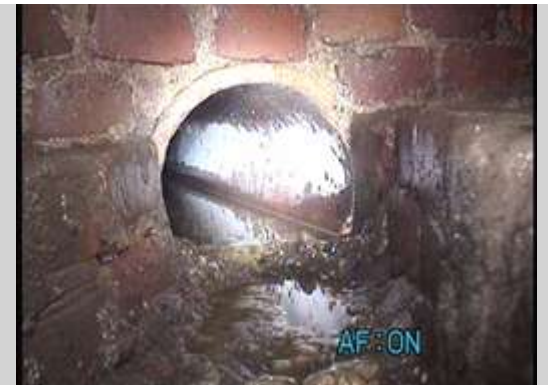
3 O'Clock Inflow

8 in. Circular Gravity Sewer
Pipe In @ 3 O'Clock

Pipe Height: **8.4** (in.) Rod and Bar (Angled)
Pipe Material: **Clay** ☐ Pipe Lined
Invert Depth: **8.10** (ft.) Flow Characteristics: **None**
Deposits: ☐ None ☒ **Mud** ☐ Sludge ☒ **Debris** ☐ Grease
Silt Depth: **2** (in.) Deposits Extent: **Light**
Infiltration: **None** Pipe Seal Cond: **Sound**

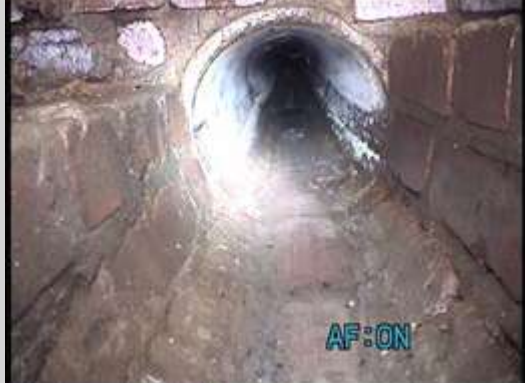
6 O'Clock Inflow

8 in. Circular Gravity Sewer

Pipe In @ 6 O'Clock

Pipe Height: **8.4** (in.) Rod and Bar (Angled)

Pipe Material: **Clay** ☐ Pipe Lined

Invert Depth: **8.00** (ft.) Flow Characteristics: **Slow**

Deposits: ☒ None ☐ Mud ☐ Sludge ☐ Debris ☐ Grease

Infiltration: **None** Pipe Seal Cond: **Sound**
